# PERFORMANCE AUDIT REPORT ON INSTALLATION AND MAINTENANCE OF ROAD FURNITURE

KENYA NATIONAL HIGHWAYS AUTHORITY  
KENYA URBAN ROADS AUTHORITY AND  
THE KENYA RURAL ROADS AUTHORITY

NOVEMBER 2020

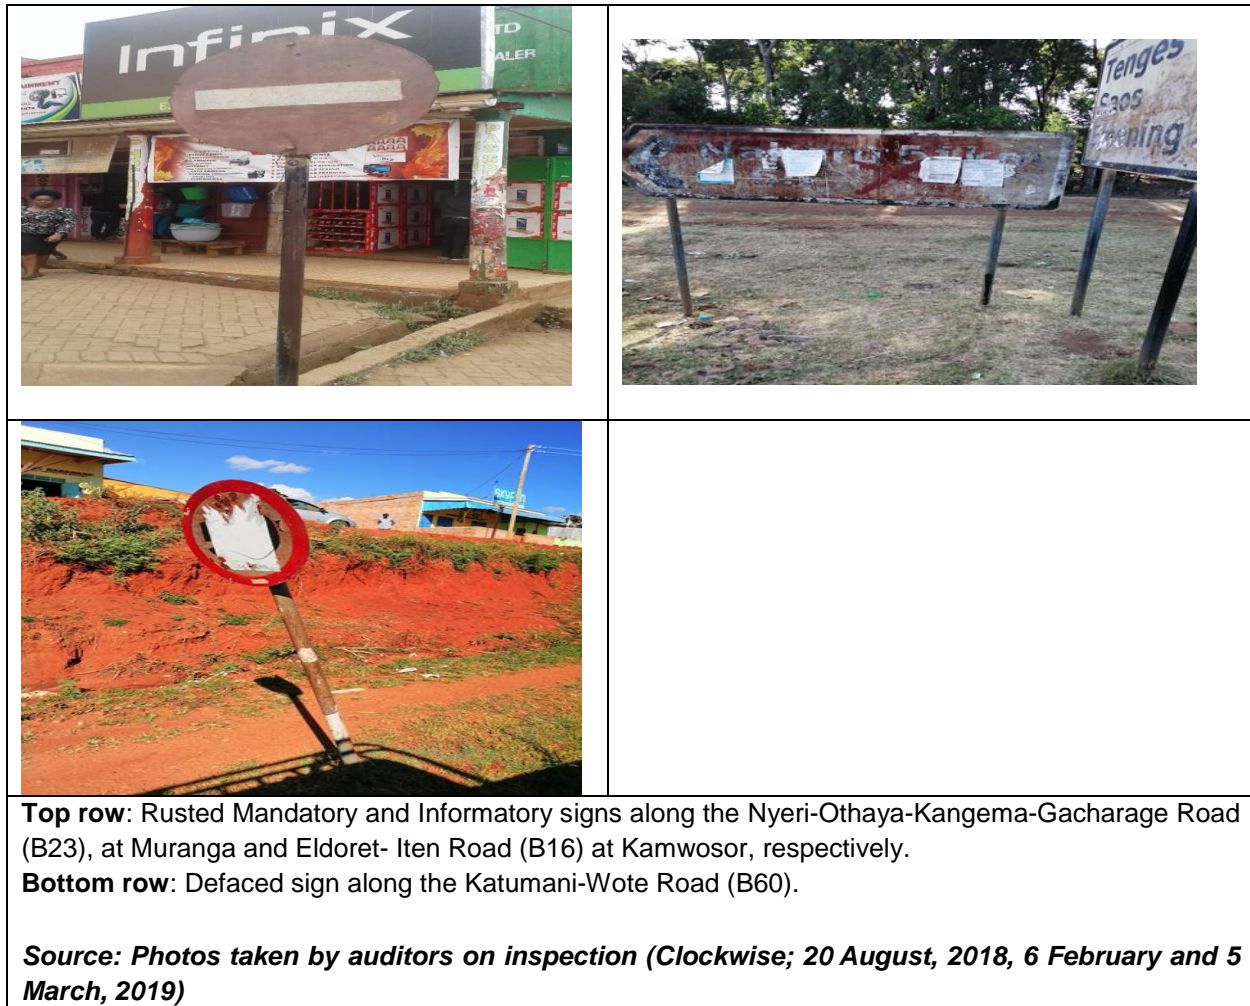
**Figure 2: Road Signs that were Defaced, Faded and had Rust**

4.14 **Figure 2** shows roads with road signs that were defaced, faded and had rust. These roads were under Performance-Based Contracts that were about to lapse;

- i. The Nyeri-Othaya-Kangema-Gacharage Road (B23), which had a defaced signage, faded road markings and damaged guardrails;

- ii. The Eldoret-Iten Road (B16) with damaged guardrails; and
- iii. The Katumani-Wote Road (B60) which had a defaced signage.

4.15 Minimal or lack of maintenance could be attributed to the fact that road furniture is not given priority during planning for maintenance. This is evident from the ARICS report reviewed that did not capture the condition of road furniture. This means that recommendations on aspects to be included in the work plans for maintenance may lack the necessary work to be carried out on road furniture. Consequently, maintenance may not be adequately done. Lack of maintenance of road furniture has direct and indirect cost as neglected road structures and signs may lead to road accidents.

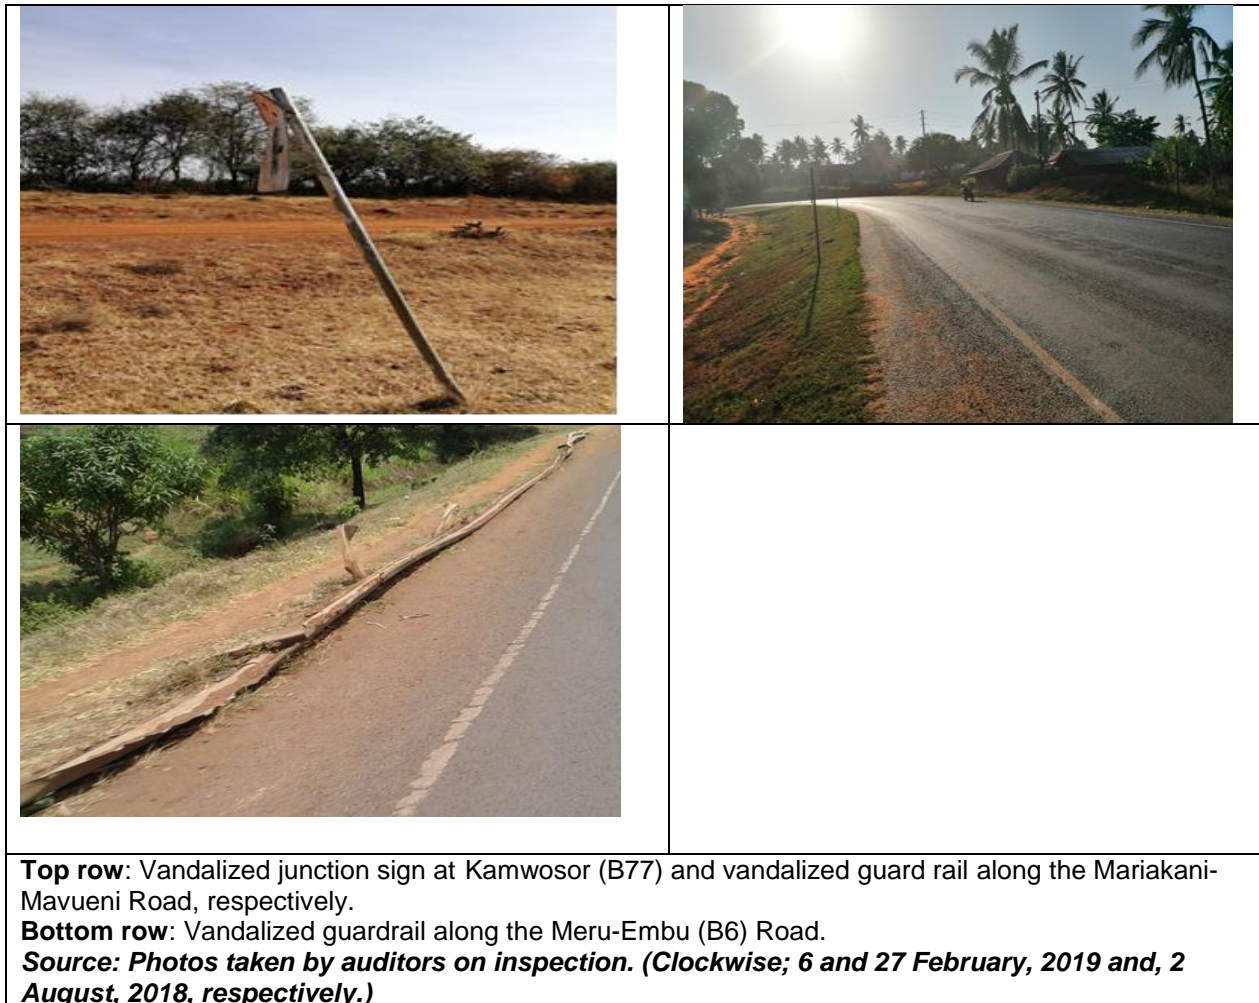
**Figure 3: Vandalised Road Furniture**

4.17 During field visits between January and March 2019, it was observed that there were cases of vandalism of road furniture on the roads inspected. In total, there were 50 vandalized road signs, 40 vandalized guardrails and 14 vandalized bridge rails on the 22 roads inspected. The Gilgil-Mau Summit Road (A8), Machakos-Kitui Road (B62) and Mariakani- Kaloleni- Mavueni Road (B91) are among the roads that had the greatest number of vandalized road furniture as shown on **Appendix 10** and in **Figure 3**.

4.18 The sustained vandalism of road furniture can be attributed to inadequate monitoring of road furniture and lack of mechanisms for reporting vandalism which would encourage the road users to promptly report vandalism. It was also noted that the material used for

roads signs, mostly metallic, are more susceptible to vandalism because of the relatively high market value of scrap metal. In addition, the Scrap Metal Act, enacted in 2015 to make provisions for the regulation of dealing in scrap metals had not been operationalised by the Ministry of Trade and Industry at the time of the audit.

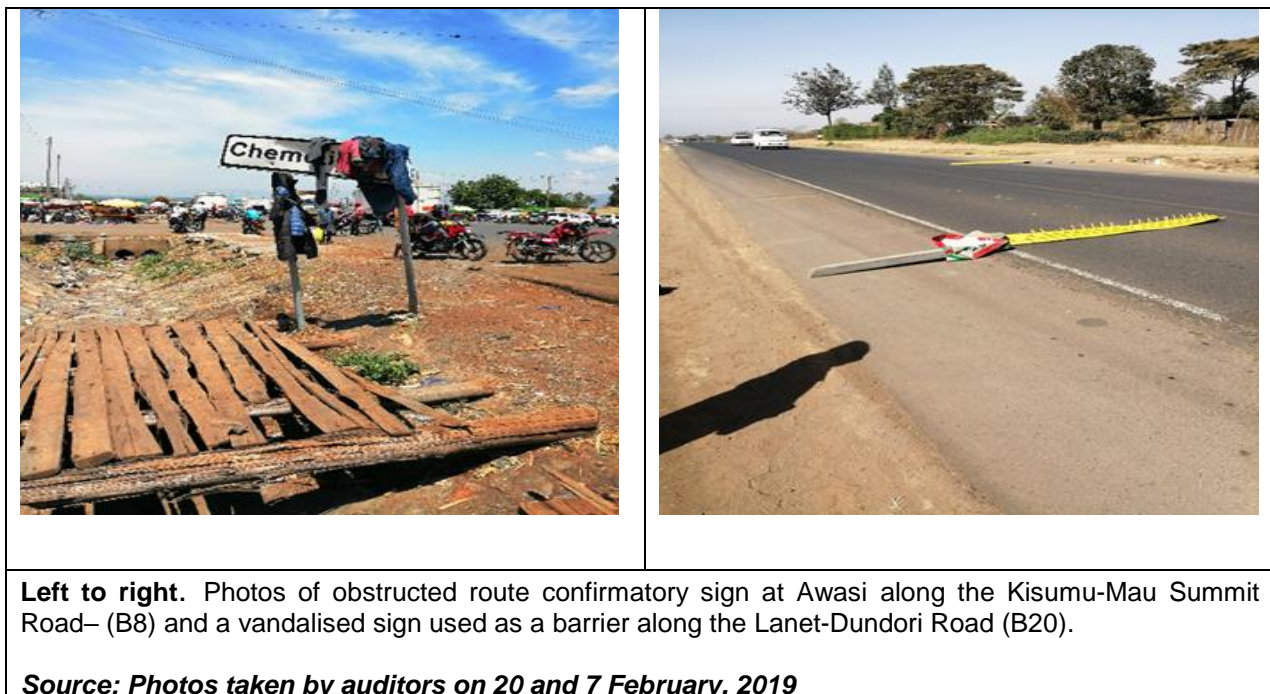
**Figure 4: Inappropriate use of Road Furniture by the Public**

- 4.19 Interviews conducted during the audit revealed that KeNHA does not carry out adequate sensitization campaigns to educate the public on the importance of protecting road furniture. The Regional Offices were allocated Ksh. 3 million every year for sensitisation and demarcation of road reserves. The officers interviewed revealed that a large proportion of this funding is mainly prioritised for demarcation of road reserves and sensitisation of the public. This is particularly in areas where the Authority is planning to demolish structures that are on road reserves. **Figure 4** shows inappropriate use of road furniture by the public.

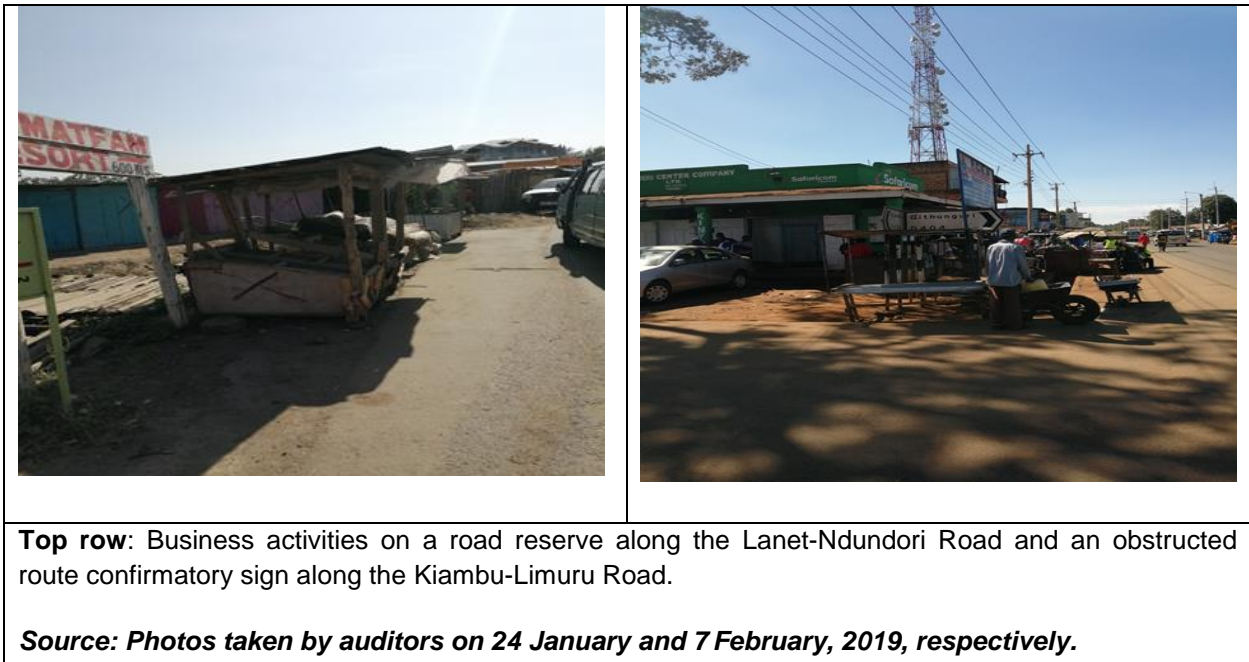
**Figure 5: Encroachment along Roads**

4.22 During the audit inspection between January and March 2019, it was observed that 10 out of 22 roads inspected were not demarcated. For instance, the Eldoret-Kapsabet Road (B8), Ekero-Ebuyango Road (C781), Kiambu-Limuru Road (B32), Lanet-Ndundori Road (B20) and Mavueni-Sabasaba Road (A7) had been encroached with building structures, businesses and farming activities as depicted in **Figure 5**.

- 4.25 Encroachment results to blockage of drainages and obstruction of visibility of road signs, leading to serious compromise on road safety. Failure to collaborate with stakeholders leads to encroachment on road reserves as a result of conflict of interest among various agencies such as county governments.

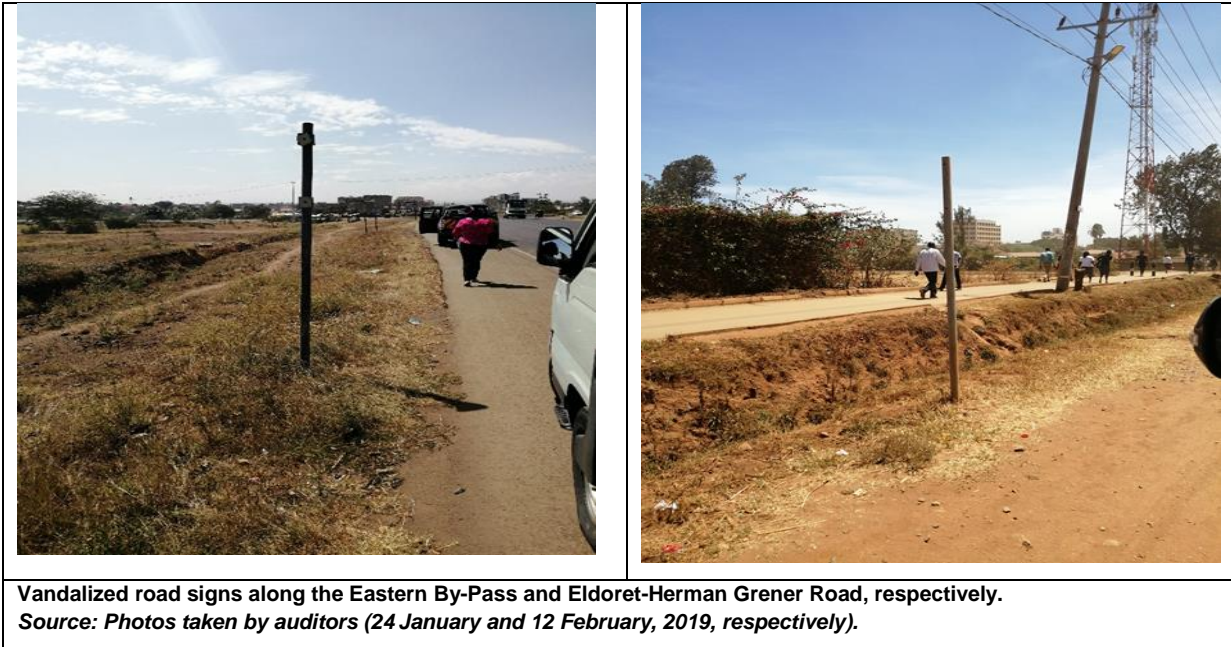
**Figure 6: Vandalised Road Furniture**

- 4.37 Road Furniture plays an important role in communicating important messages as well as protecting road users. They are important assets and as such should be protected from vandalism.
- 4.38 During field visits in January, February and March, 2019, it was observed that there were cases of vandalism of road signs on the roads inspected. Some of the roads that had vandalised road furniture are Eastern and Northern Bypass, Eldoret-Herman Greener School Road, Kisambai-Sabatia Road in Kakamega and Bangladesh-Baringo Road in Nakuru, among others. **Figure 6** shows photos of vandalised road furniture taken during the audit.

- 4.39 The sustained vandalism of road furniture can be attributed to lack of continuous inspection and monitoring of road furniture and lack of mechanisms for reporting vandalism. Reporting mechanisms would encourage road users to promptly report vandalism. It was also noted that the material used for road signs, mostly metallic, is more susceptible to vandalism because of the relatively high market value of scrap metal. In addition, the Scrap Metal Act, enacted in 2015 to make provisions for the regulation of dealing in scrap metals had not been operationalised by the Ministry of Trade and Industry at the time of the audit.

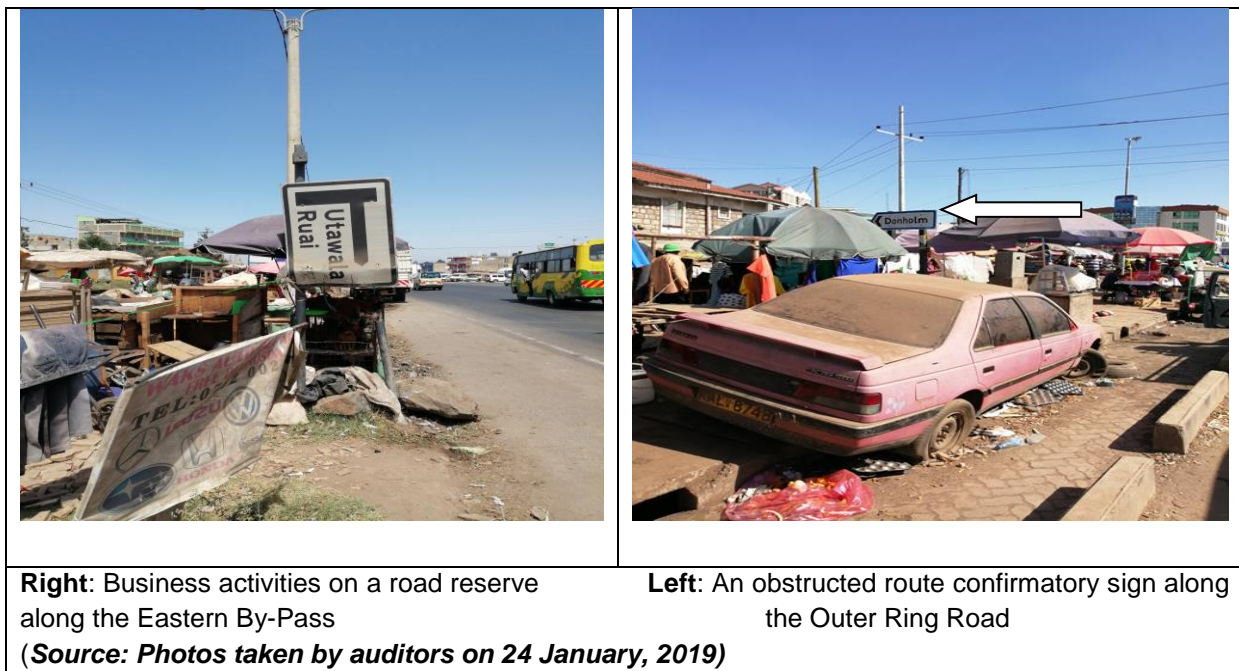
**Figure 7: Encroachment on Roads**

- 4.43 During the field inspection in February and March 2019, it was observed that all the KURA roads inspected, except for the Eastern Bypass, were not demarcated. It was also observed that 17 out of the 24 roads inspected were encroached. This is depicted in **Figure 7** and **Appendix 12**.

- 4.44 Encroachment results to blockage of drainages and obstruction of visibility of road signs, leading to serious compromise on road safety. Interviews with Regional Managers revealed that collaboration with stakeholders on roadside development activities was not adequate.

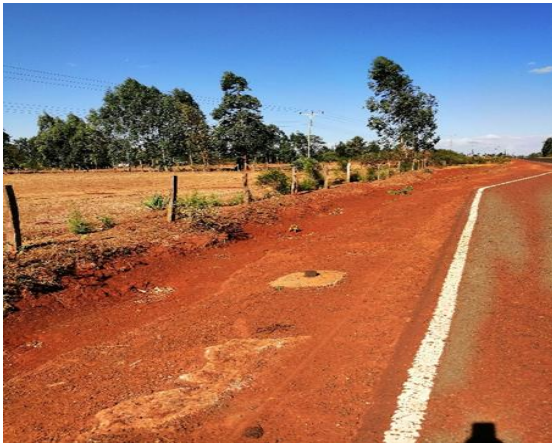
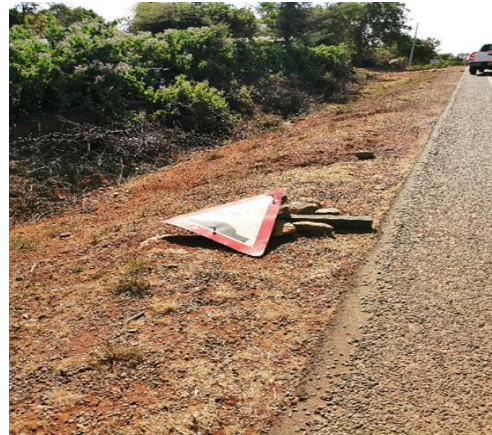
**Figure 8: Vandalised Road Furniture**

- 4.56 According to the Road Design Manual–Geometric Design for Rural Road Part 1, Chapter 3 (b); road signs and lighting supports and other utility poles should be located far enough from the carriageway to reduce the likelihood of being struck by out of control vehicles, or they should have break-way capability.
- 4.57 During field visits between January and March 2019, it was observed that there were cases of vandalism of road signs on the roads inspected. Some of the roads that had vandalised road furniture are Jua Kali-Sugoi Road, Marula-Kongoni Road, Kabiria Road and SGR-Mkupe Jetty Road among others as shown in **Figure 8**.

**Top row:** Vandalized road sign along the Jua Kali-Sugoi Road; Uasin Gishu County.

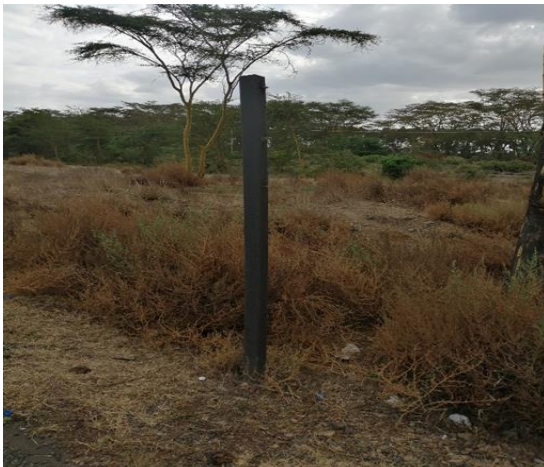
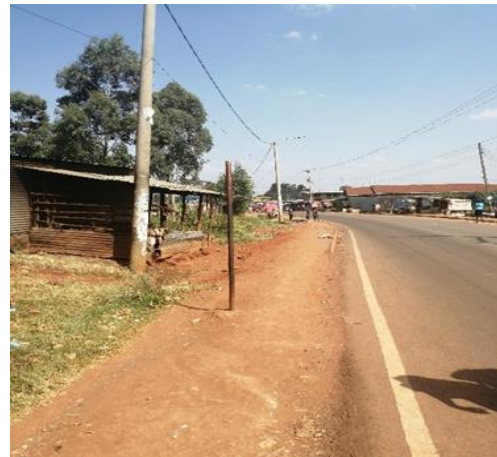
**Bottom row:** Vandalized road sign along the Marula-Kongoni Road in Nakuru County and Kabiria Road in Dagoretti South; Nairobi County.
