PERFORMANCE AUDIT REPORT ON
PROVISION OF SEWERAGE IN MAJOR TOWNS
IN KENYA:
A CASE STUDY OF NAIROBI CITY

ATHI WATER SERVICES BOARD

APRIL 2018

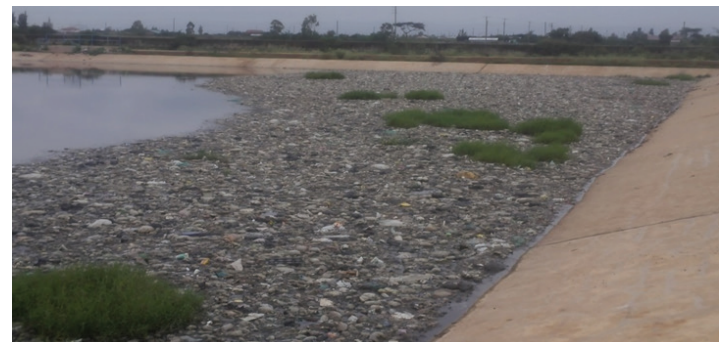
Plate 1: Littered pond in Dandora Estate Waste Water Treatment Plant

4.13 Field observations revealed that a similar investment incurred by AWSB in 2010 intended to automate litter collection at the DEWWTP failed

to deliver. The installed machines broke down and stalled in less than a year due to corrosion since they could not stand the high acidity of the effluent. Interviews with NCWSC revealed that AWSB did not adequately assess the needs before installing the machines, otherwise the board would have known that the machine would not stand the toxicity of the effluents. As at the time of the audit, the inlet works was being operated manually, allowing litter, including plastic bags, to pass and accumulate in the ponds as illustrated in **Plate 1**.

Notice the amount of litter in this pond sufficing as evidence of a malfunctioning inlet works

- 4.27 Field verifications revealed that an investment intended to mechanize the collection of trash at DEWWTP inlet works failed only a year after it was handed over to NCWSC. The machine broke down in 2010 and has not been repaired since then as NCWSC considered its maintenance costs too high. Interviews revealed that the required spare parts for the broken down machines are not available in the local market, hampering maintenance works. As the facilities are abandoned, the environment will continue to be polluted with partially treated sewage as has been the case of Kariobangi Waste Water Treatment Plant.

4.33 Our visit to DEWWTP revealed that an automated machine installed at the inlet works to collect and trapped litter at the filters broke down in 2010 and has not been repaired to date. The trash crusher also broke down in 2013 and no repairs have been done to date. As a result, much of the solid waste, including plastics which the system is intended to trap escape into the ponds. It was observed that the DEWWTP stabilisation ponds had plastics and other solid waste floating all over. Besides, the litter is collected manually, left to dry before it is burnt, posing an air pollution hazard.

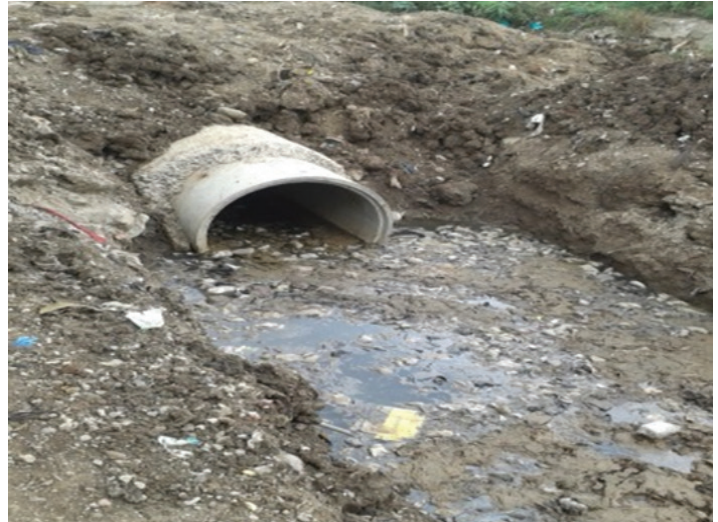
Plate 2: Incomplete section of Sewer Blue Estate, Nairobi

- 4.21 The delays meant that the environment continued to be polluted awaiting completion of the sewerage projects as illustrated in **Plate 2**. The condition could even get

Due to wayleave challenges the sewer line remained incomplete discharging raw sewage into the environment

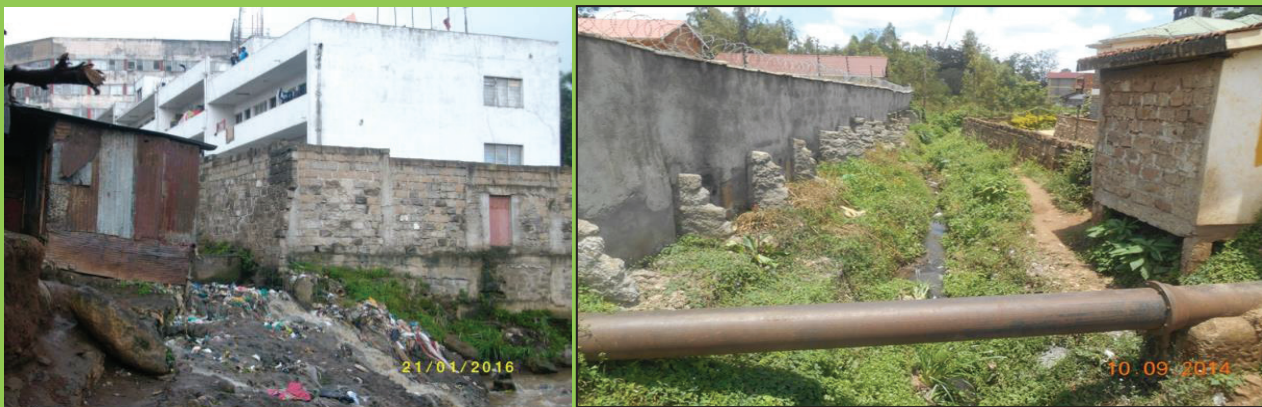
In Nairobi, for instance, it was noted that most of the riparian wayleaves have been encroached, generally in places like Kirichwa Ndogo, Mathare, Kariobangi and Kawangware among others. This mainly affected the implementation of NWSEPIP 4a- Mukuru Sewers and NaRSIP Lots I, II and III in which case some of the encroachers were reluctant to move even after compensation, for example in Blue Estate hence delaying the projects. It became impossible to lay down some sections of the sewer line due to the encroachment of wayleaves by permanent structures as was observed in the border between Mathare and Pangani estates. In some instances, AWSB was forced to acquire wayleaves from private land owners, but this was never easy. The consultant engineer for NaRSIP informed the team that KenHA charged them exorbitantly for every lane crossed along the Thika Super Highway, despite them using the under passes for rivers to lay the sewer lines without interfering with the road. The audit team also observed an unfinished 40m section of NaRSIP Lot I in Githurai-44 area due to a private land owner refusing to issue right of way despite AWSB willing to pay for the wayleave.

Notice the encroachment of buildings into wayleaves in Nairobi posing a challenge for laying down of sewer lines

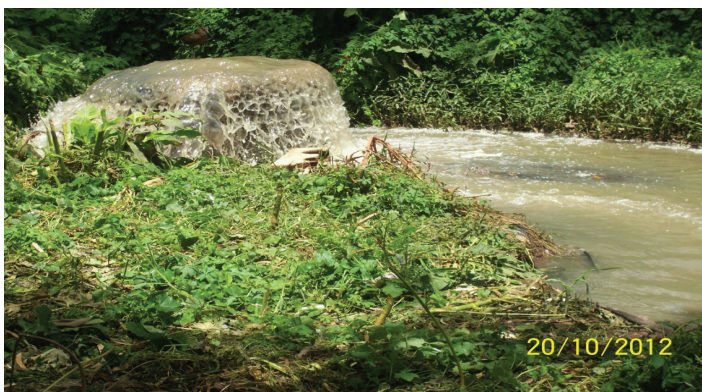
Plate 3: An Overflowing Manhole Near Museum Hill Round About along Nairobi River

4.32 Field observations revealed various instances of burst sewers, open and overflowing manholes and blocked sewers within Nairobi as illustrated in Plate 3. As a result, the environment is polluted with raw sewage from the failed system. The open manholes are at times used as dumping ground for solid waste further causing blockages in the system.

Notice the raw sewage flowing from the manhole causing pollution to Nairobi River

- To ensure that the existing sewerage is well maintained:-
 - AWSB in consultation with WASREB should clearly define the nature and extent of repair and maintenance responsibilities and be proactive in taking responsibility for the same

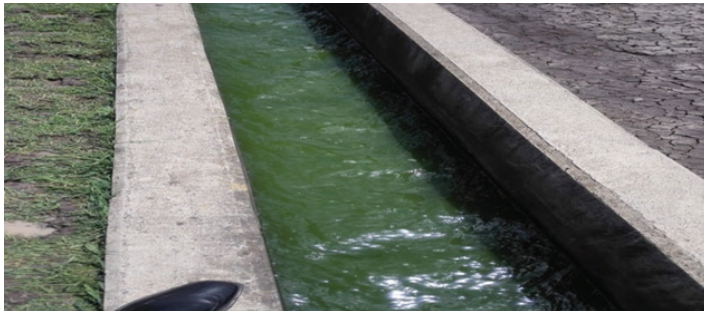
Plate 4: Physical appearance of water at Dandora ponds outlet terrace

4.35 As a result of inadequate maintenance, the treated sewage being discharged back to the environment both from DEWWTP and Kariobangi waste water treatment works do not meet NEMA recommended quality standards as measured by Biological Oxygen Demand (BOD), Chemical Oxygen Demand (COD) and Total Suspended Solids (TSS). Table 5 illustrates the quality level of effluents discharged back to the environment from Kariobangi waste water treatment works during the audit period.

Notice the green colour of effluent indicating high level of algae, a clear indication of high concentration of nutrients, especially phosphates and nitrates.

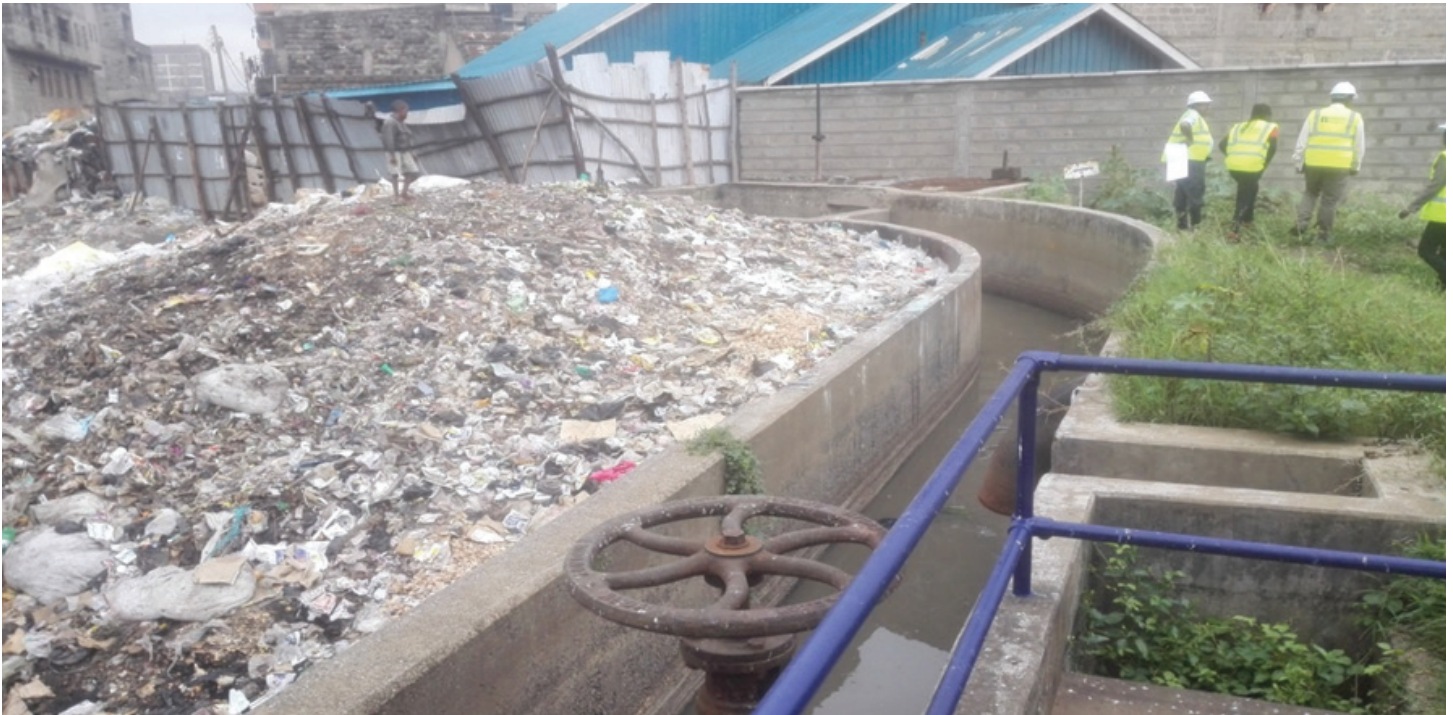
Plate 5: Human encroachment into Kariobangi Waste Water Treatment Plant

Notice the buildings constructed close to the treatment plant. Also notice the solid waste dumped next to the plant's inlet works by the encroachers
